Ventilation: Heat and A/C in the Vanagon Explained

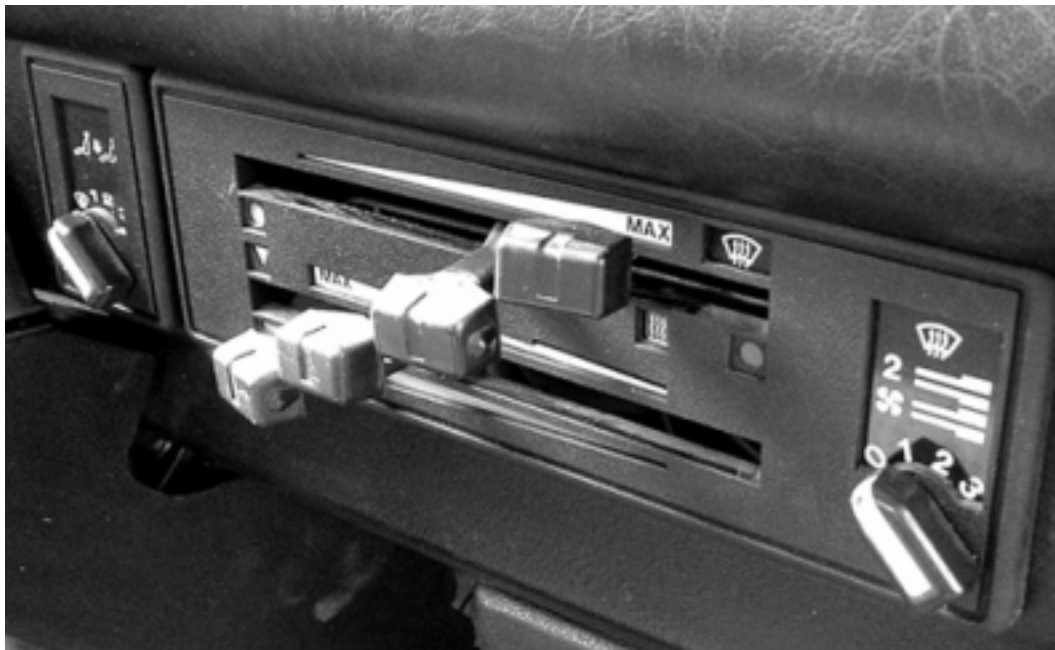
Fresh ambient air enters the vehicle through the front radiator grille between the headlights. Behind the radiator grill is a smaller grill (about 2" x 24") for fresh air intake, attached to a duct welded to the body. Fresh air flows through this duct to an air distribution box, which is about 1' x 1' x 2' in size, and is buried in the dashboard, dead center about a foot below the windshield. This air distribution box has several cable controlled flaps on it, and it houses an electric "squirrel cage" fan which is controlled by the rotary fan knob to the right of the slide levers. On all water-cooled models it also houses a small radiator called a "heater core." There are cables attached to the four slide levers that control the amount, temperature, and direction of fresh air that comes into the vehicle:

TOP LEVER: The "defrost" lever. This lever operates a cable that moves flaps in the air distribution box, increasing or decreasing fresh airflow to the windshield and front door windows. The air flows via the four air ducts on the top surface of the dashboard (numbered "1" and "2" in your owner's manual, page 45). The air controlled by this lever can be either cool or heated air, depending on where the second lever is positioned.

SECOND LEVER: The next lever down is the "heater" lever. It operates a cable that controls the heater valve(s). On air-cooled models, there are two cables that are about a mile long and go all the way back to the engine heater "flaps" on the heater boxes mounted to the engine, one on each side. On water-cooled models, this lever controls a single cable that is only about three feet long and operates a water "heater valve," located right behind the radiator cooling fan outside the vehicle (or right behind the glove box inside the vehicle on 1982 water-cooled diesel models). In either case, this lever controls the *temperature* of the air entering the vehicle.

THIRD LEVER: This lever operates a cable that moves flaps in the air distribution box, increasing or decreasing air flow to your feet. This air flows via an air duct assembly just in front of the gear shift lever. On some diesel models there is a false floor down the aisle way which ducts air to the rear passenger area. (On 83-91 water-cooled gasoline powered Vanagons, there is an entirely separate heater under the rear bench seat for the rear passenger area, the operation of which is described in your owner's manual on page 46.) The air controlled by the third lever can be either ambient or heated air, depending on where the second lever is positioned.

BOTTOM LEVER: This is the rear passenger fresh air control lever. This lever operates a cable that moves flaps in the air distribution box under the dashboard, increasing or decreasing fresh airflow to the rear passenger area. Fresh air that enters the air distribution box is diverted to metal ducts under the dashboard which conduct air to the right and left front door jambs. In the front left and right forward door jambs there are rectangular gaskets that connect the doors to these ducts. There are still more ducts welded inside each front door through which air flows and exits out of the rear door jamb, through a funny looking plastic oval grill thingy with a furry seal around it. You can see this when you open the door and look just under the door latch. Then the air flows up inside the body section behind the front doors, and then rearward into the fresh air ducts along the roof in the rear passenger area. On camper models, the left steel duct under the dashboard is plugged so air can't flow through the left door. This is because, on campers, there are no air vents in the rear passenger area above the stove and fridge galley. You will find the oval grill thingy missing on the left door (see pic #1 below). I wish I had a dollar for every time a camper owner insisted on buying an oval furry vent thingy for the left door because it was "missing." It is *supposed* to be missing!

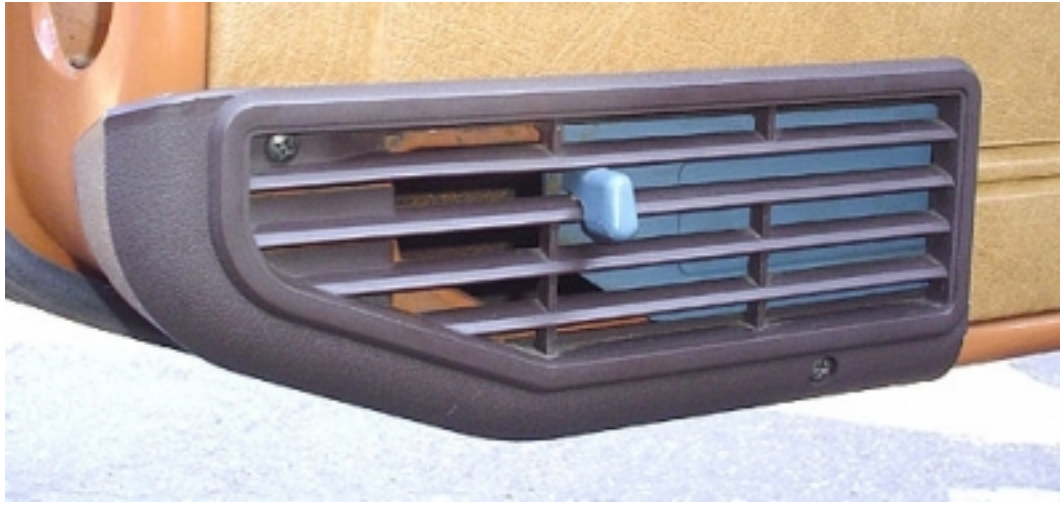
So far we have only discussed how air ENTERS the vehicle. Of course, no air can come IN unless air goes OUT. This is called "flow-through ventilation," which all vehicles have to some degree. Prior to 1988, if all windows were closed, the only way air could get out was through little exit vents located on the rear lower corner of the front door interior panels. These are the plastic vent assemblies with the little blue slide lever.

These vents allowed air to exit the interior. Sliding the lever toward the front of the vehicle opens the vent, rearward closes it. On the leading edge of the doors, in the door jam, there are three oval holes that open into this hollow space of the door itself. As a Vanagon plows through the air, air flows around the vehicle creating low-pressure zones near the front door jam areas. VW engineers realized this and used this low pressure to suck air out of the interior of the vehicle. Air flows from the inside of the vehicle through the little vent at the rear end of the front doors, through the hollow door itself, into the door jam area, and out of the body gap between the front door and front quarter panel. Genius, you say. But what about the rear passengers, you say? And why, in 1988, did VW put a rubber seal at this body gap, thus blocking all airflow through it?

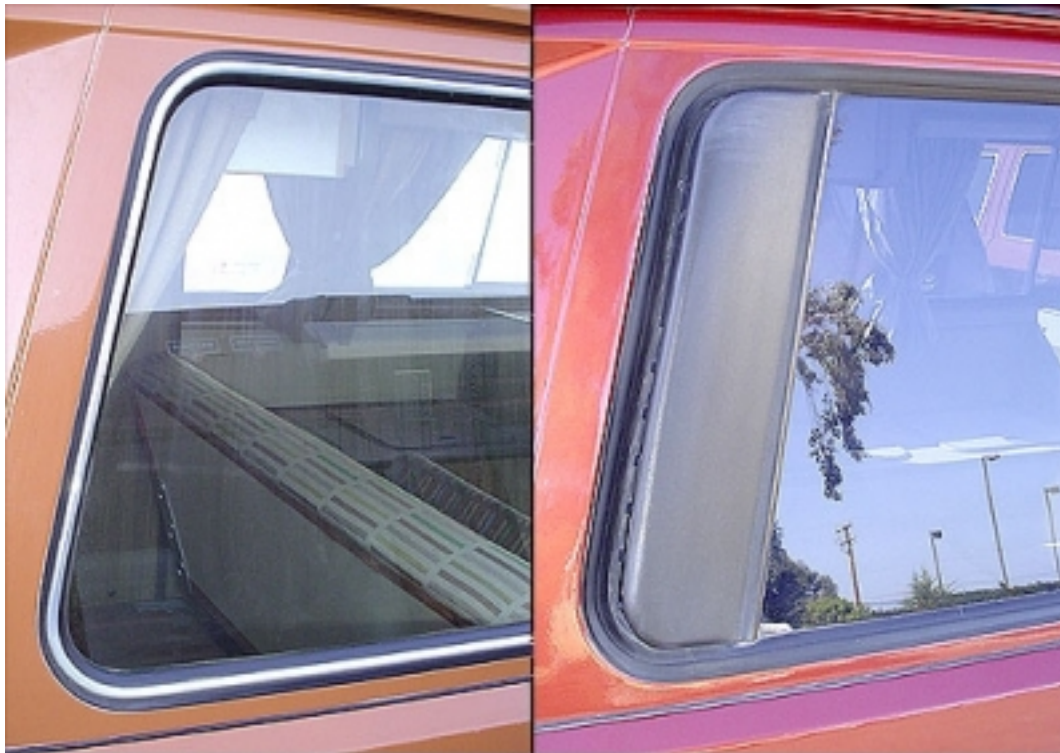
The flow through ventilation scheme completely changed and improved in 1988. This change coincided with the introduction of the switch from chrome (or black) steel bumpers to the fiberglass "big bumpers" and the accompanying front spoiler. In 1988 the rear-most side windows have an added vent along the rear edge. It was necessary to shorten the glass in order to make room for this vent as the opening in the body stayed the same. These vents are air EXIT vents.

Interestingly, the little grills on the front door panels remained, but if you remove them you will see the passageway behind them is sealed, and there is no blue slide lever. The seal at the door gap area was put there probably for reduced noise. I installed these seals on my 1987 Vanagon, and added the rear vents too. It actually lowered the wind noise a little, and the rear vents improved air flow inside the vehicle, especially for the rear passengers. And now I have the best of both worlds: improved flow-through ventilation and cool air from the dash vents! You can say you knew me when I was nobody...

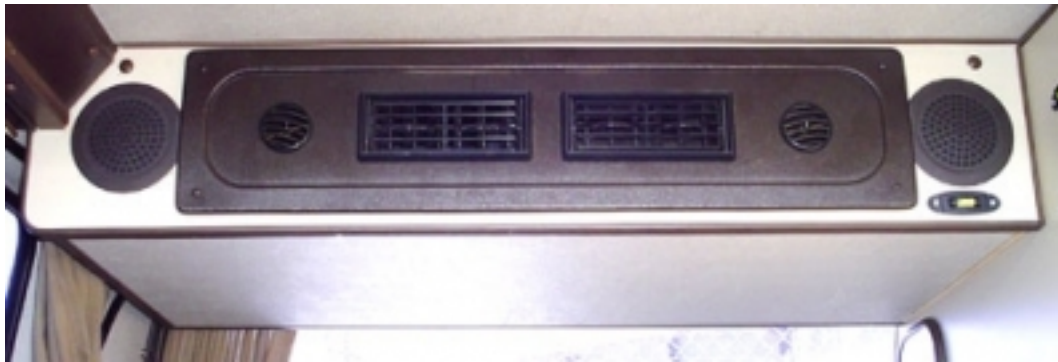
1984-1986: On these year models, the air conditioning evaporator was located inside what would normally be the rear cabinet above the rear seat. Instead of the little cabinet door that flips down there was a grill assembly installed. This system did not work very well. See picture below.

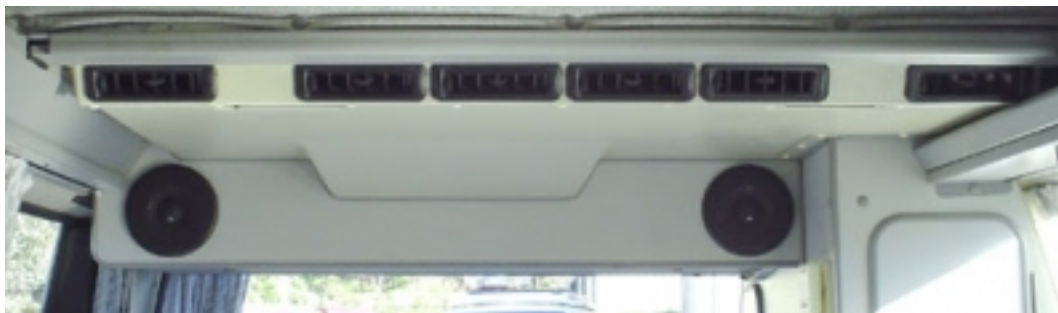
1987-1991: Factory A/C was improved in 1987, which coincided with the switch in the campers from a tan colored interior to gray. On 87-91 pop-top Vanagons without A/C, the rear cabinet was the same shape and size as the 80-86. With factory A/C, the entire rear cabinet assembly changed. Whereas the pre-87 system was basically a converted cabinet, the new system had an additional duct assembly that came right up to the edge of the rear ceiling, thus getting much closer to the front passengers. This system also used a larger evaporator and evaporator fans, a larger condenser with a more powerful radiator fan, and a larger A/C compressor (7-cylinder instead of 5 cylinder). This system worked OK, but still was nothing to write home about. The people in the back seat would be deafened from the roar of the more powerful evaporator fans, and frozen solid from the increased airflow. The folks in the front seat by comparison would be barely comfortable. However, this system when operating properly will keep the interior cool, and is fine for two people traveling in the FRONT seats. See picture below.
